# Service Bulletin

Bulletin No.: 12-06-04-003

**Subject:** Diagnosis and Repair - Malfunction Indicator Lamp (MIL) Illuminated, Reduced Engine Power Message Displayed, DTC P2135 Set

**Models:** 2009-2011 Buick Lucerne  
2006-2008 Chevrolet Malibu  
2006-2011 Chevrolet Impala  
2006-2009 Pontiac G6  
Equipped with Engine RPO LGD, LZ4, LZ8 or LZE

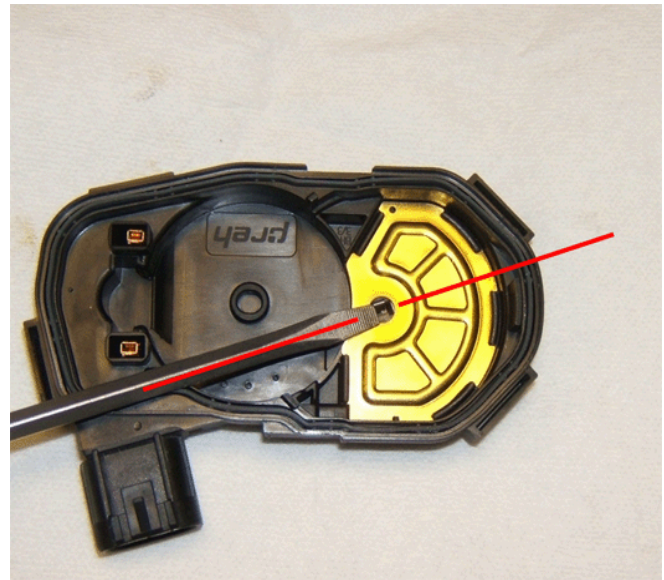
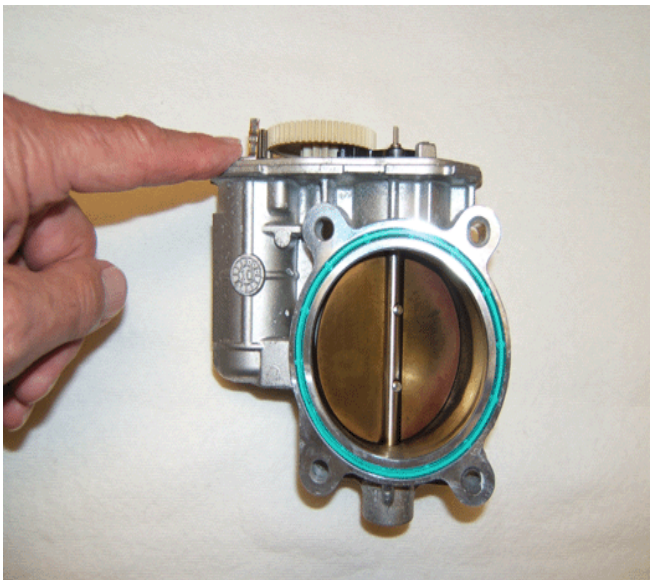
13. Observe the TP sensor cover for missing female throttle actuator motor terminals (1). Verify that the female throttle actuator motor terminals **have remained** in the TP sensor cover and **have not** been retained on the throttle actuator motor male terminals as shown. Discard the old TP sensor cover, gasket and terminals.

⇒ If one or both of the TP sensor cover female throttle actuator motor terminals have been retained on the throttle actuator motor male terminals, remove and discard those female terminals.

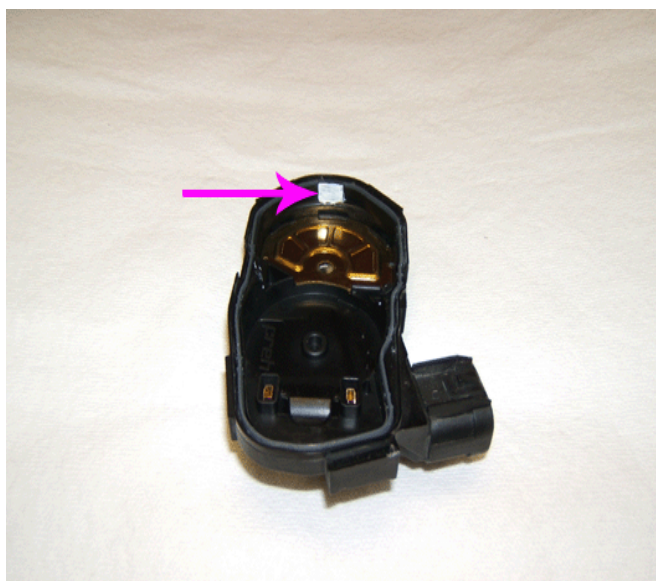
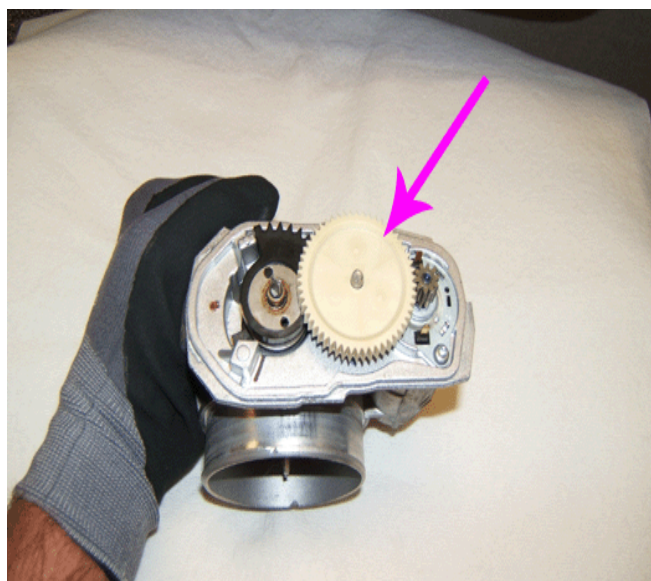
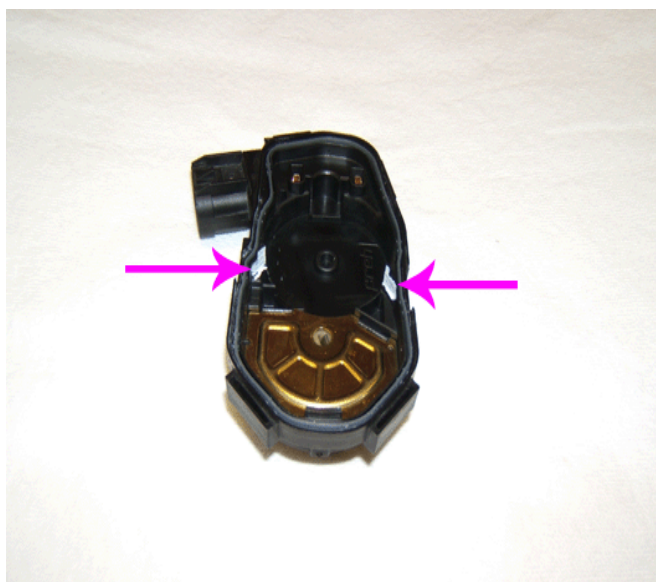
17. Verify that all three of the TP sensor cover alignment tabs are present and are not damaged.

16. Verify that the TP sensor cover gasket is secure and properly positioned.
